# Manhole Inspection Summary

Manhole # S19KK\_040MH

**Location** Address: **1948 RIDGEHILL-WALBROOK** Cross Street: **PAYSON-MONROE**

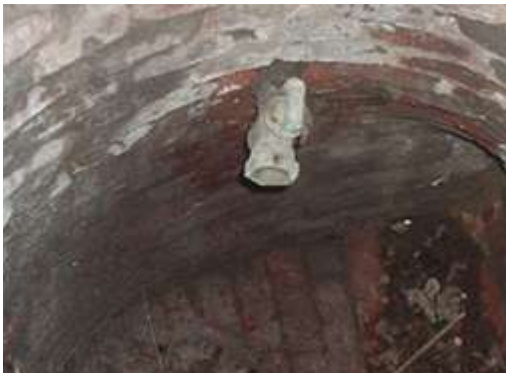
DEBRIS

VALVE COMING OUT OF CORBEL WALL

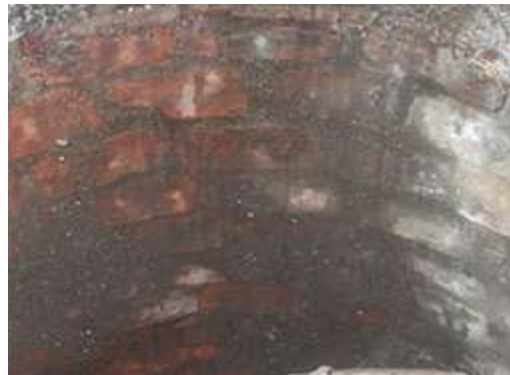
Defect 1

**Chimney / Frame Adjustment** ☒ Exists Material: **Brick** ☐ Parged Height: **3** (in.)  
Condition: ☒ Sound ☐ Cracked ☐ Root Intrusion ☐ Loose Brick ☐ Deteriorated  
Infiltration: ☐ None ☐ Joint ☐ Cracks ☐ Mortar ☐ Roots ☒ **Wall**

INFILTRATION OF CHIMNEY WALL

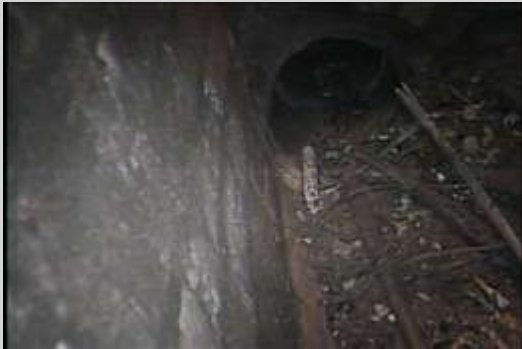
12 O'Clock Outflow

8 in. Circular Gravity Sewer  
Pipe Out @ 12 O'Clock

Deposits: ☐ None ☐ Mud ☐ Sludge ☒ **Debris** ☐ Grease

Silt Depth: **2** (in.) Deposits Extent: **Light**
